Manhole Inspection Summary

Manhole # S43WW_011MH

Insp Date: **2/22/07 12:06 PM**

Location Address: **3220 KIRK AVE**

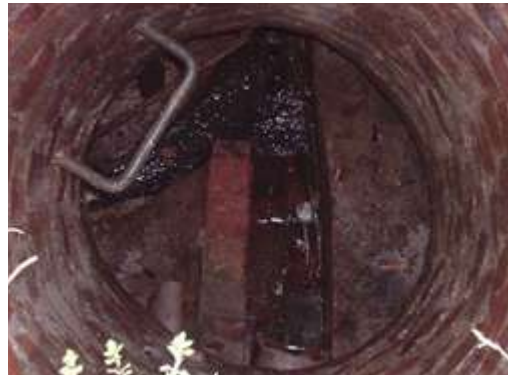
Top View

Corroded steps. Evidence of surcharge - Bench debris.

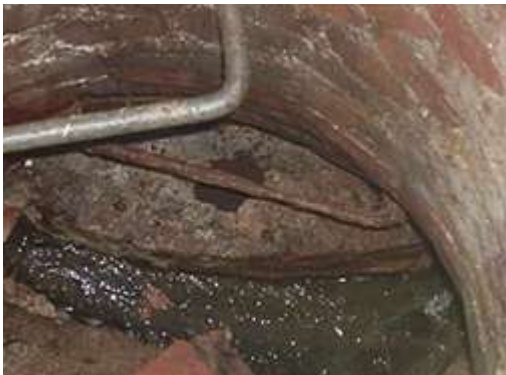
Defect

Steps Count: **2** Missing: **0** ☒ **Corroded**

Corroded step.

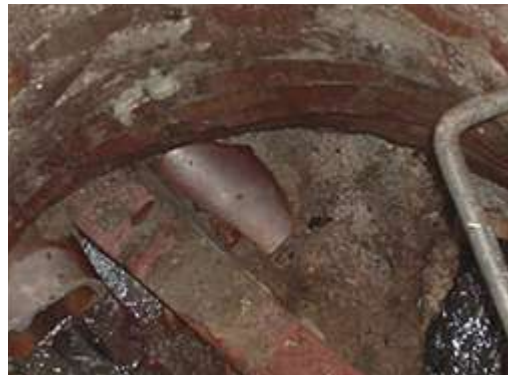
Defect

Infiltration: ☐ None ☐ Joint ☐ Cracks ☐ Mortar ☐ Roots ☒ **Wall**

Barrel infiltration.

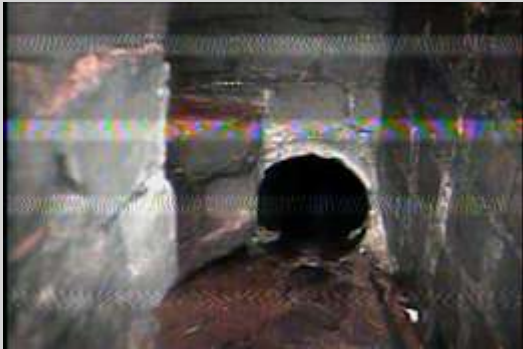
8 in. Circular Gravity Sewer Pipe Out @ 12 O'Clock

Infiltration: **None** Pipe Seal Cond: **Cracked**

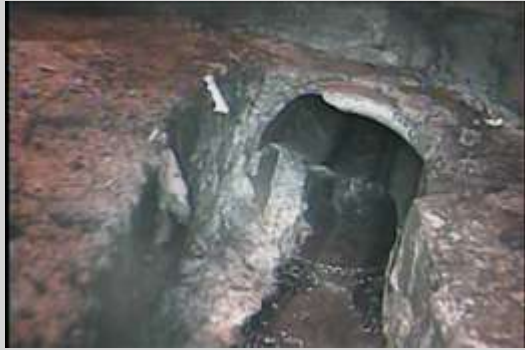
8 in. Circular Gravity Sewer

Deposits: ☐ None ☒ **Mud** ☐ Sludge ☐ Debris ☒ **Grease**

Deposits Extent: **Light**

Pipe Seal Cond: **Broken**
